## **Intertidal Bathymetry and Shoreline Mapping**

# **GNSS-Interferometric Reflectometry**

## **Marine Litter Detection service**

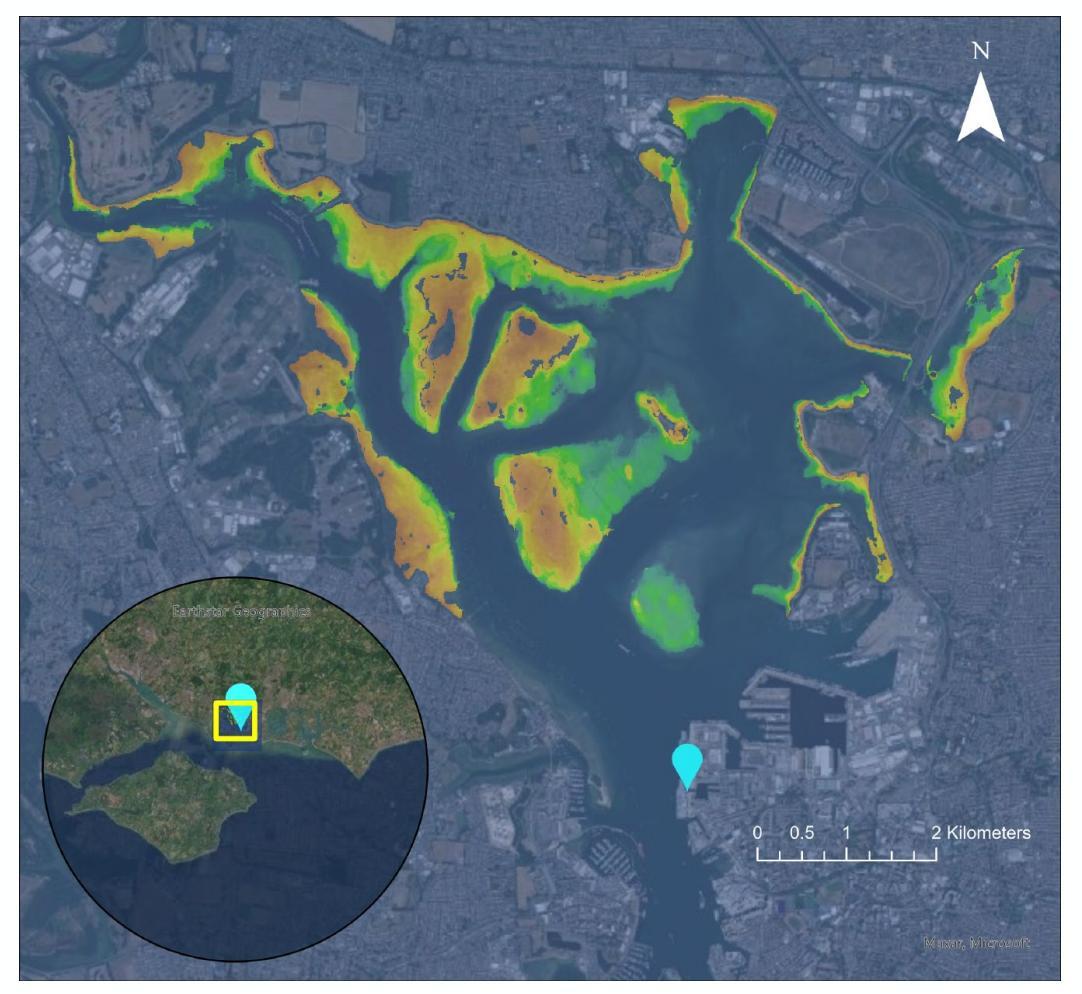
Image shows 6 month composite of intertidal heights for Portsmouth Harbour (Nov 2015- May 2016) using on Portsmouth Tide Gauge

- Efforts have focused on **intertidal topography mapping** using SAR (Temporal Waterline mapping or TWL)
- Service development has been user driven through regular meetings with the Channel Coastal Observatory EO Working Group (c. 20 members from coastal authorities, environmental agency and survey specialists)
- **Validation study** conducted using Portsmouth Harbour comparing LIDAR surveys from 2016, 2018 and 2020 against 6 month composites of SAR processed data

- To date UK applications have relied on 'flat tide' approximation (i.e. water levels from nearest tide gauge are assumed flat across survey area) this oversimplification is being addressed by integrating spatially varying tides e.g. POLPRED & FES
- In parallel team are developing `**confidence layer**' that quantifies the uncertainties and limitations tailored to user needs

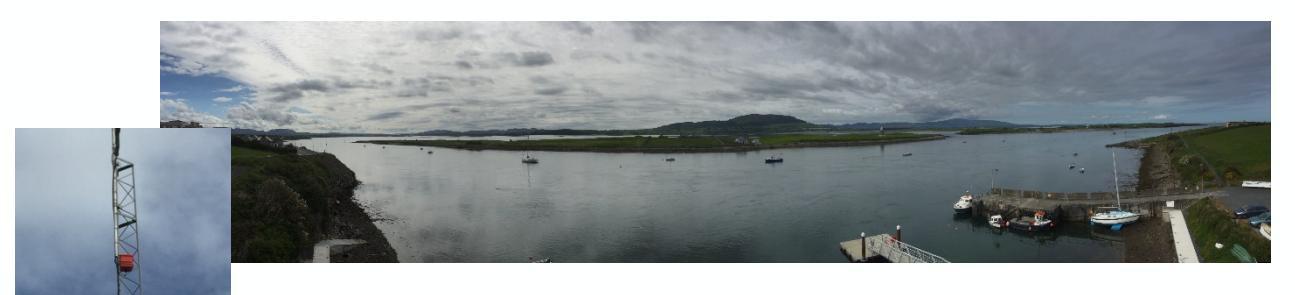
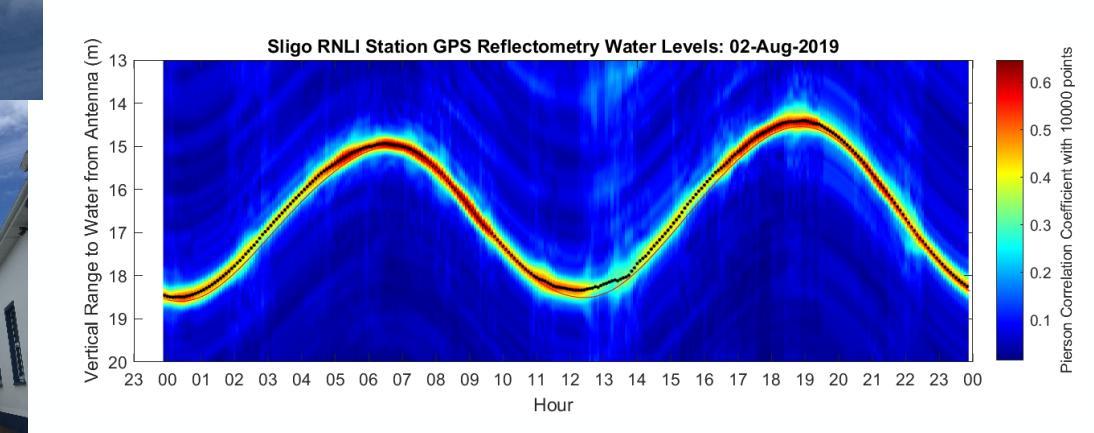
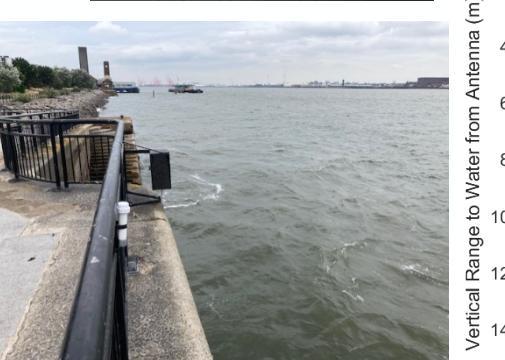
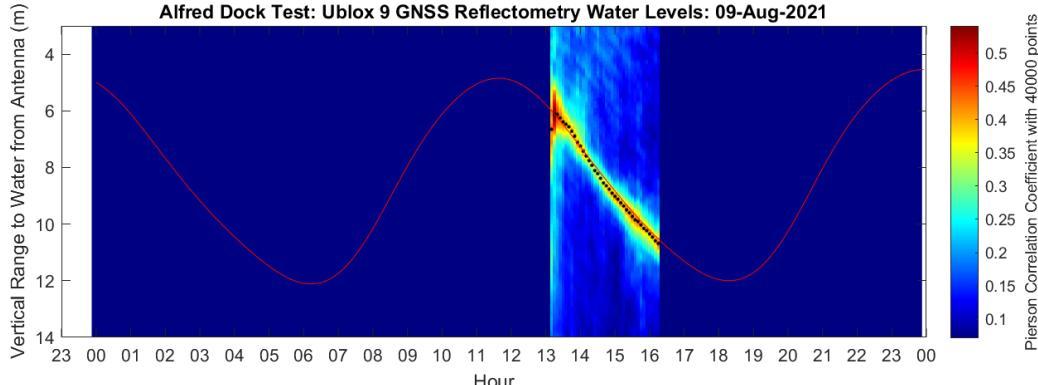
**Original 2018 Loctips Project:** low cost Sirfstar IV GPS L1 receiver deployed at Sligo Bay Lifeboat Station in Ireland – **Still operational after 3 years**.

Max of 2-4 satellites available for water level detection, but occasionally **no** satellites in a good configuration. GPS Broadcast Ephemeris obtained direct from receiver for real time processing

**BLUECO Update:** New low cost uBlox 9 Receivers implemented with GPS, GLONASS, GALILEO & BEIDOU constellations. Always some satellites in useful configuration, sometimes 15+ satellites in a configuration useful for water level (& wave height) detection. All Broadcast Ephemeris obtained direct from receiver.

*Bottom Right*: Pre-EMEC deployment configuration testing with a laptop & receiver at Alfred Dock on the Mersey Estuary (local site with ground truth data)

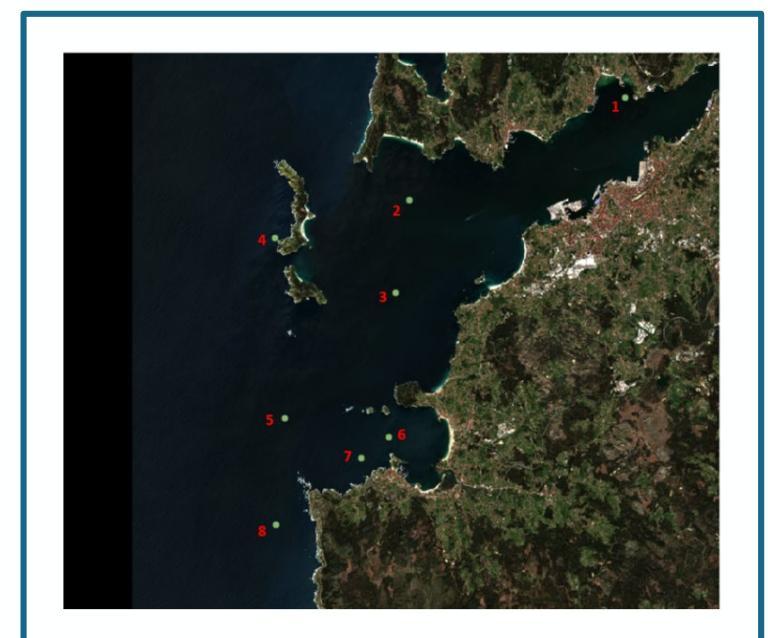
Plastics detection analysis performed in Vigo River estuary

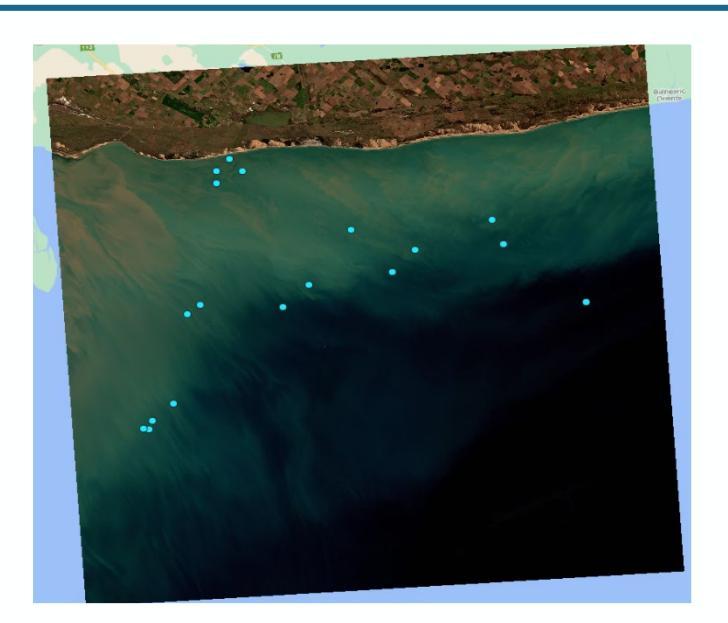
Plastics detection analysis in Front of the El Rincón estuary

Feature		Value
· 20200	)821_high [4]	
▼ ID		0
•	(Derived)	
•	(Actions)	
	Туре	LDPE
	MinFrac	0.1
	MaxFrac	0.15
	ConfLev	High
	PosErr	3 pixels
	ID	0
	Lon	-60.901315092239862
	Lat	-39.188067167818780
	Date	20200821
	layer	S2B_MSIL2A_20200821T135119_N0214_R
	path	C:/GMV/Projects/On-going/ATIN-BLUECO/10
► ID		1
► ID		2
→ ID		3
Mode Curr	ent Layer	-
View Tree	v	Help
Ou	itputs	provided - type
_	c	
C	or blas	stic, amount of
-		
	alacti	c(0/a)/imaga
	JIASLI
